**RESEARCH  
REPORT  
NO.90-1**

# **Membrane and Flashing Condition Indexes for Built-Up Roofs Volume II: Inspection and Distress Manual**

**by  
Mohamed Y. Shahin  
David M. Bailey  
Donald E. Brotherson**

**Building Research Council, University of Illinois, Champaign, IL  
In cooperation with the US Army Corps of Engineers  
Construction Engineering Research Laboratory**

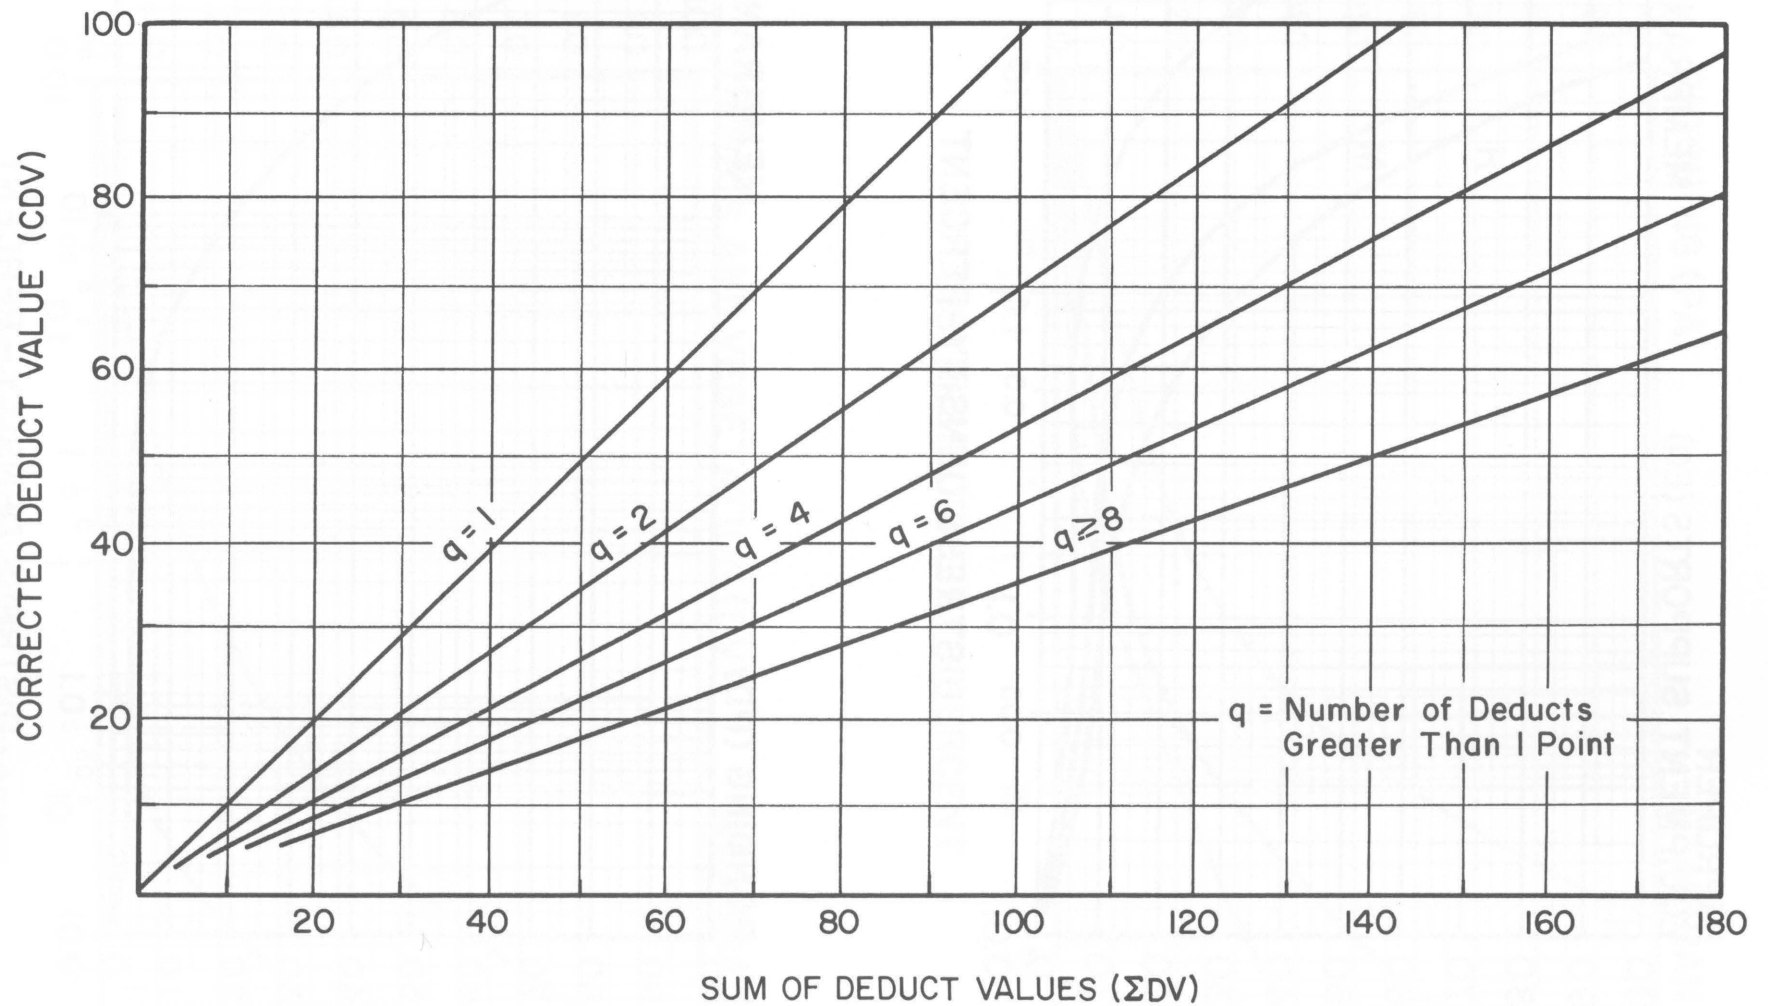
Corrected deduct values for membrane.
